## Ljósmyndir 1935-1970

Bjarni Benediktsson – Geimfarið Ranger VII – Lyndon B. Johnson – Tunglmyndir

*Photographs taken by  
Ranger VII spacecraft  
prior to its impact on the moon  
July 31, 1964*

*Presented to  
His Excellency Bjarni Benediktsson  
Prime Minister of Iceland  
from  
Lyndon B. Johnson  
President of the United States of America  
August 18, 1964*

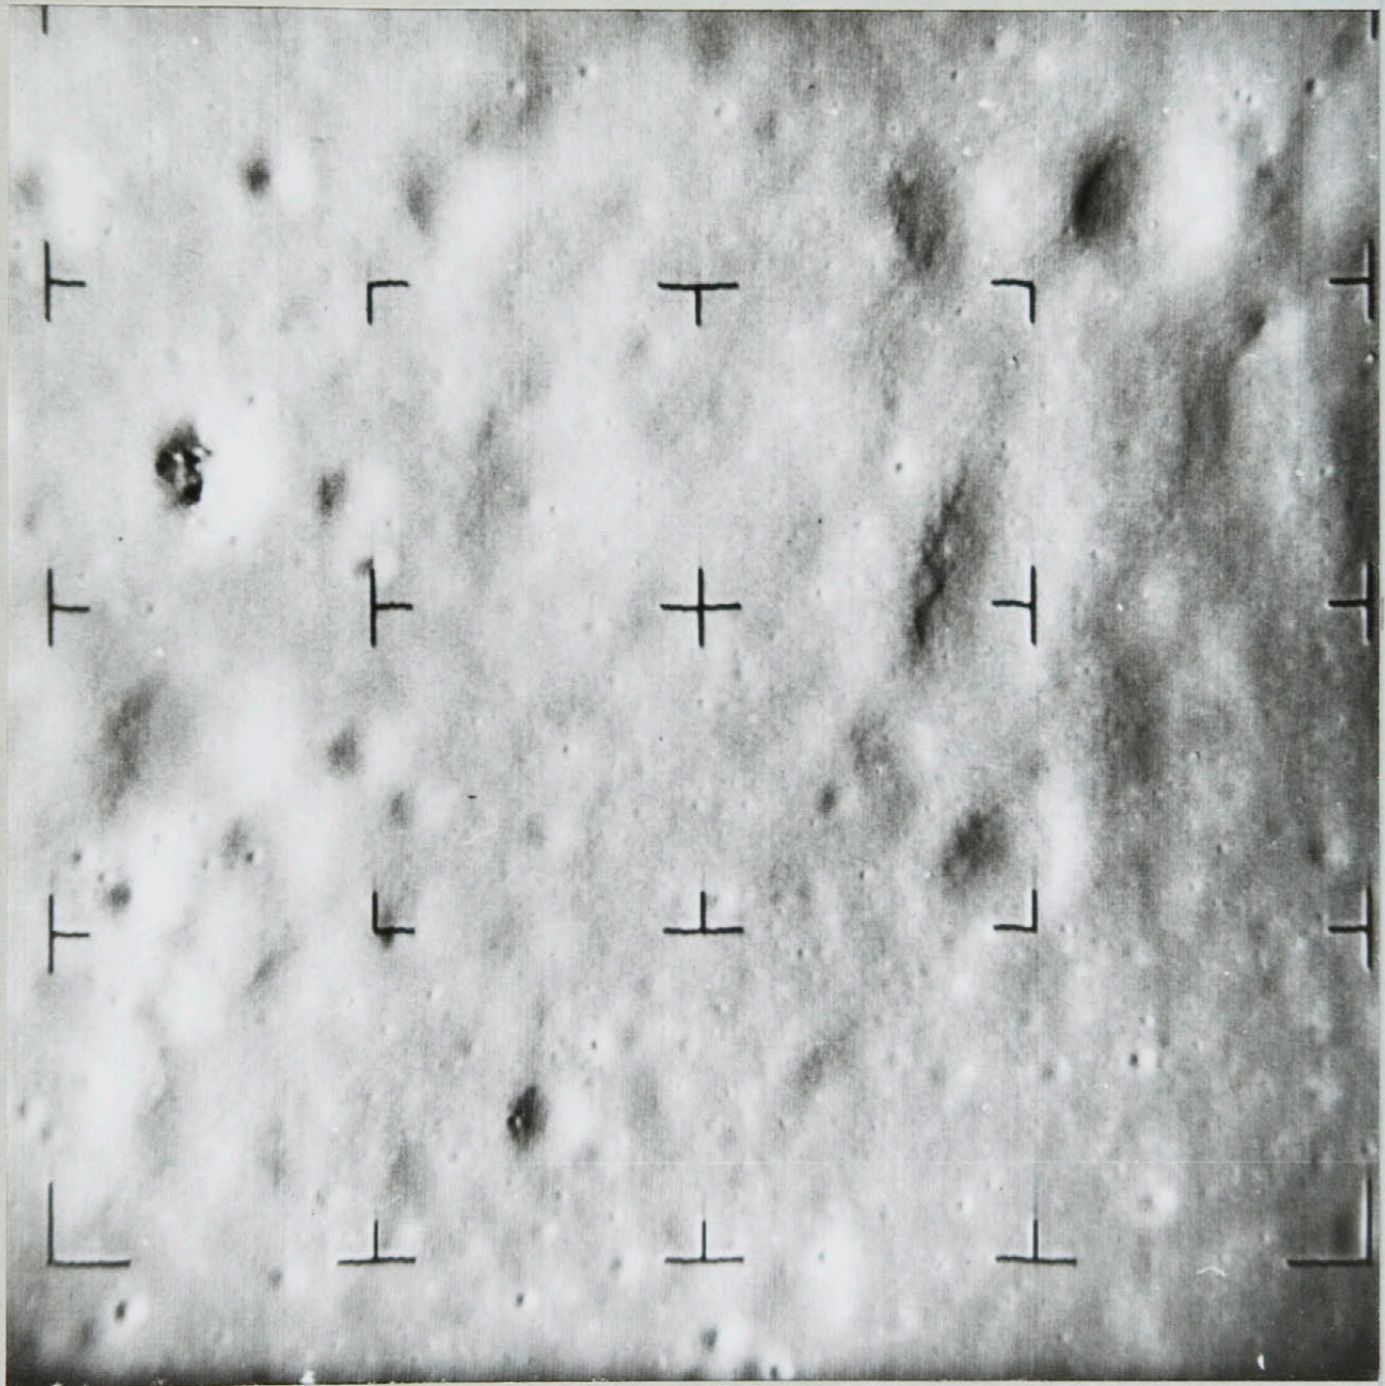
FOR RELEASE: Immediately  
PHOTO NO.: 64-Ranger B-23

Photograph taken by Ranger VII spacecraft prior to its impact on the Moon at 6:25 a.m. PDT July 31. Viewed with the partial picture and line of receiver noise at the top, North is at the top in both pictures. The top partial picture was the last taken by the P-3 camera with a 25mm, f/1 lens before Ranger VII crashed onto the Moon. The spacecraft was destroyed while transmitting, resulting in the receiver noise pattern. The picture was taken 1,000 feet above the lunar surface and is of an area about 100-feet by 60-feet. It has a resolution one-thousand times better than seen by Earth-based observations.. The smallest craters are about three-feet in diameter and one-foot in depth.

The lower complete picture, showing an area about 100-feet on a side, was taken by the P-1 partial scan camera with a 75 mm, f/2 lens at an altitude of about 3,000 feet. Many of the craters shown have rounded shoulders in contrast with most larger lunar craters.

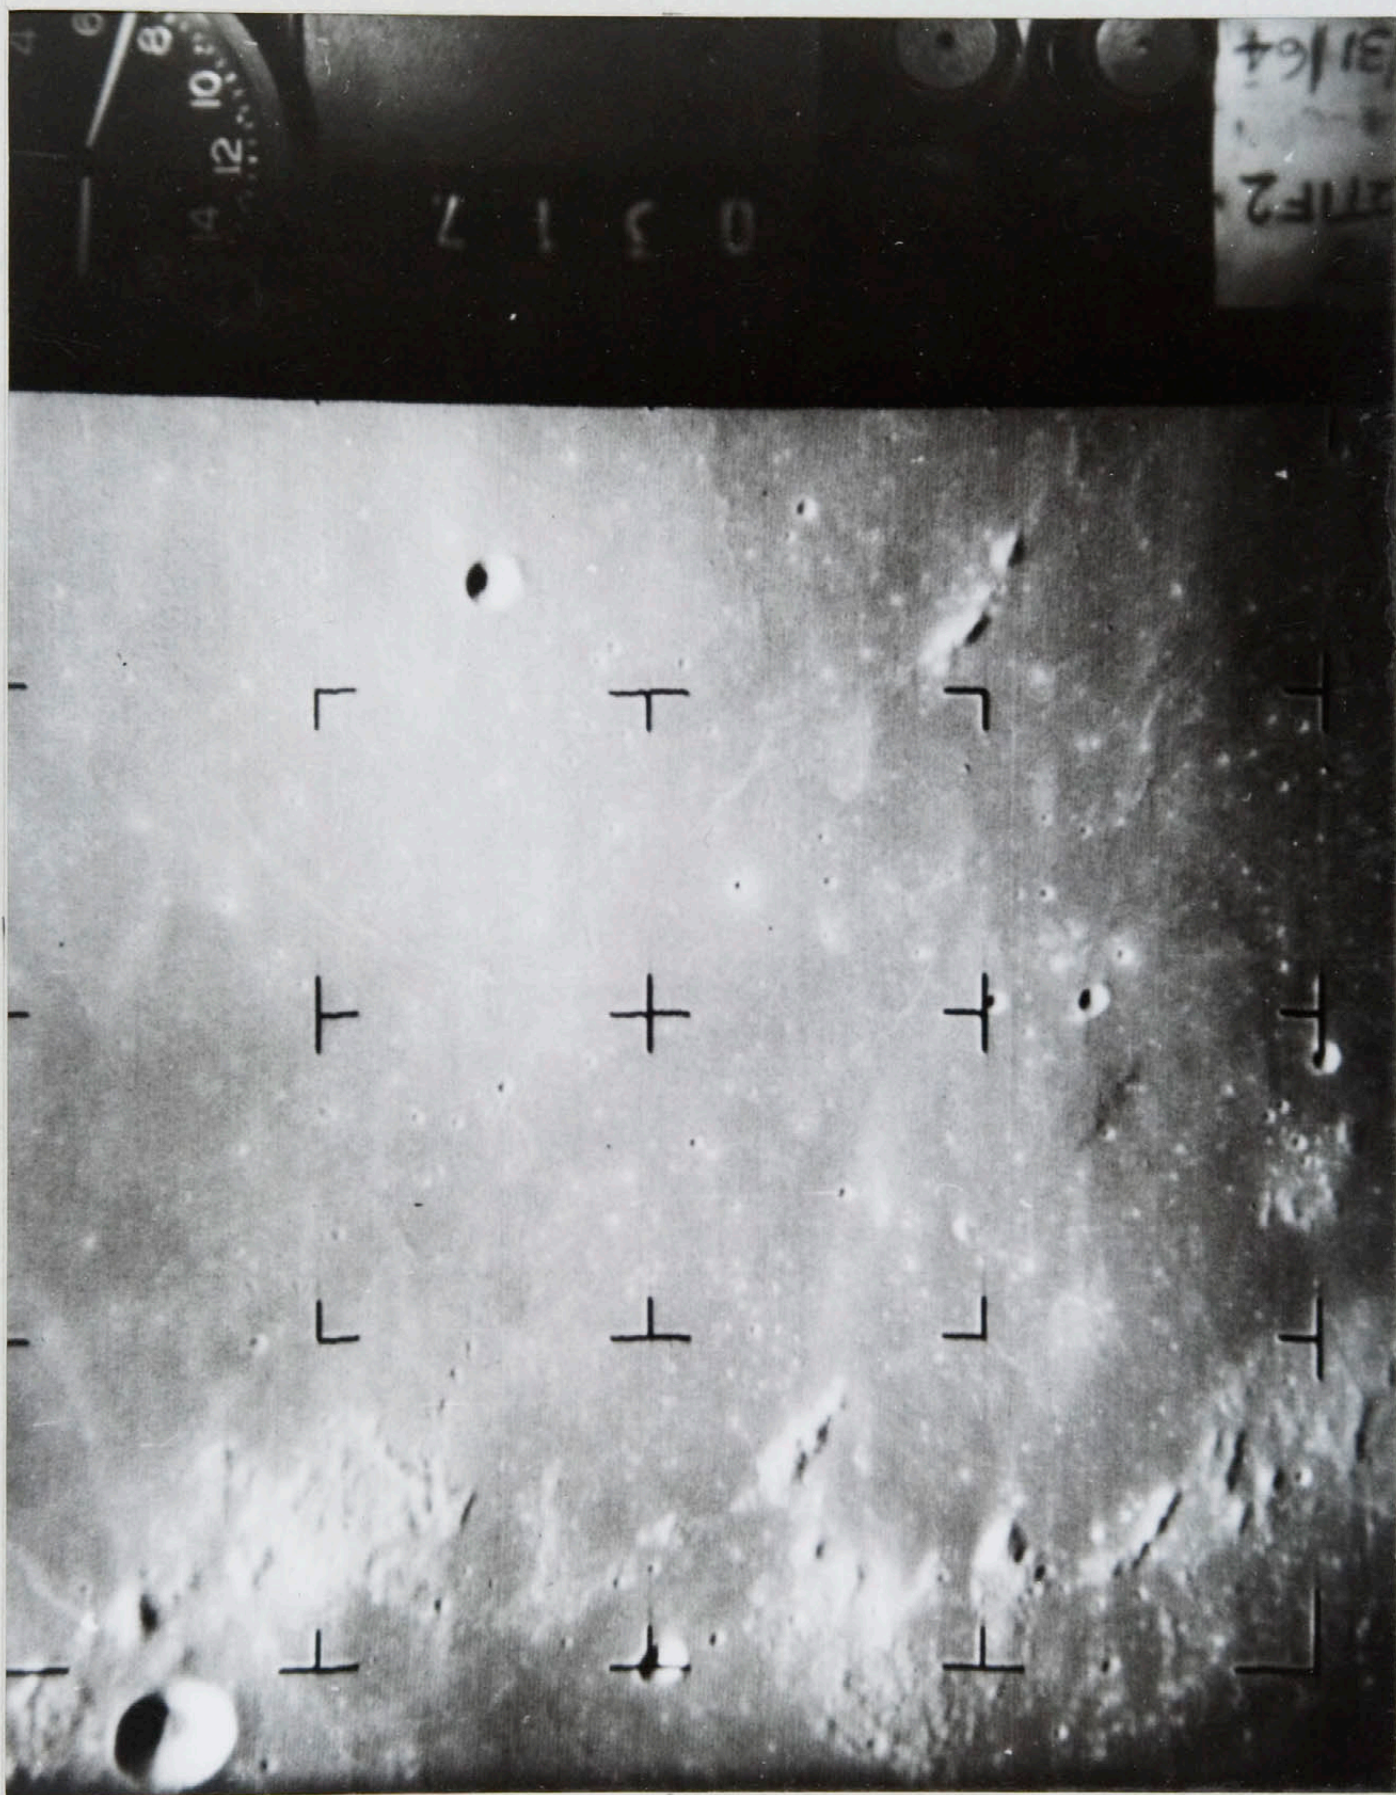
FOR RELEASE: Immediately  
PHOTO NO.: 64-Ranger B-24

Photograph taken by Ranger VII spacecraft prior to its impact on the Moon at 6:25 a.m. PDT. Viewed with the largest crater in the upper right hand corner, North is at the top of the photograph. The picture was taken by the F-2 camera with a 25mm, f/1 lens from an altitude of about three miles some 1.3 seconds before impact. The picture shows an area of about one-and-two-thirds miles on a side. The smallest craters shown are approximately 30-feet in diameter and ten-feet deep. There are many craters with rounded shoulders. One rounded crater, at left toward the top of the photograph, is about 300-feet in diameter and has an angular rock mass in its center which might possibly be responsible for its origin. Ranger is a project of the National Aeronautics and Space Administration and the Jet Propulsion Laboratory.

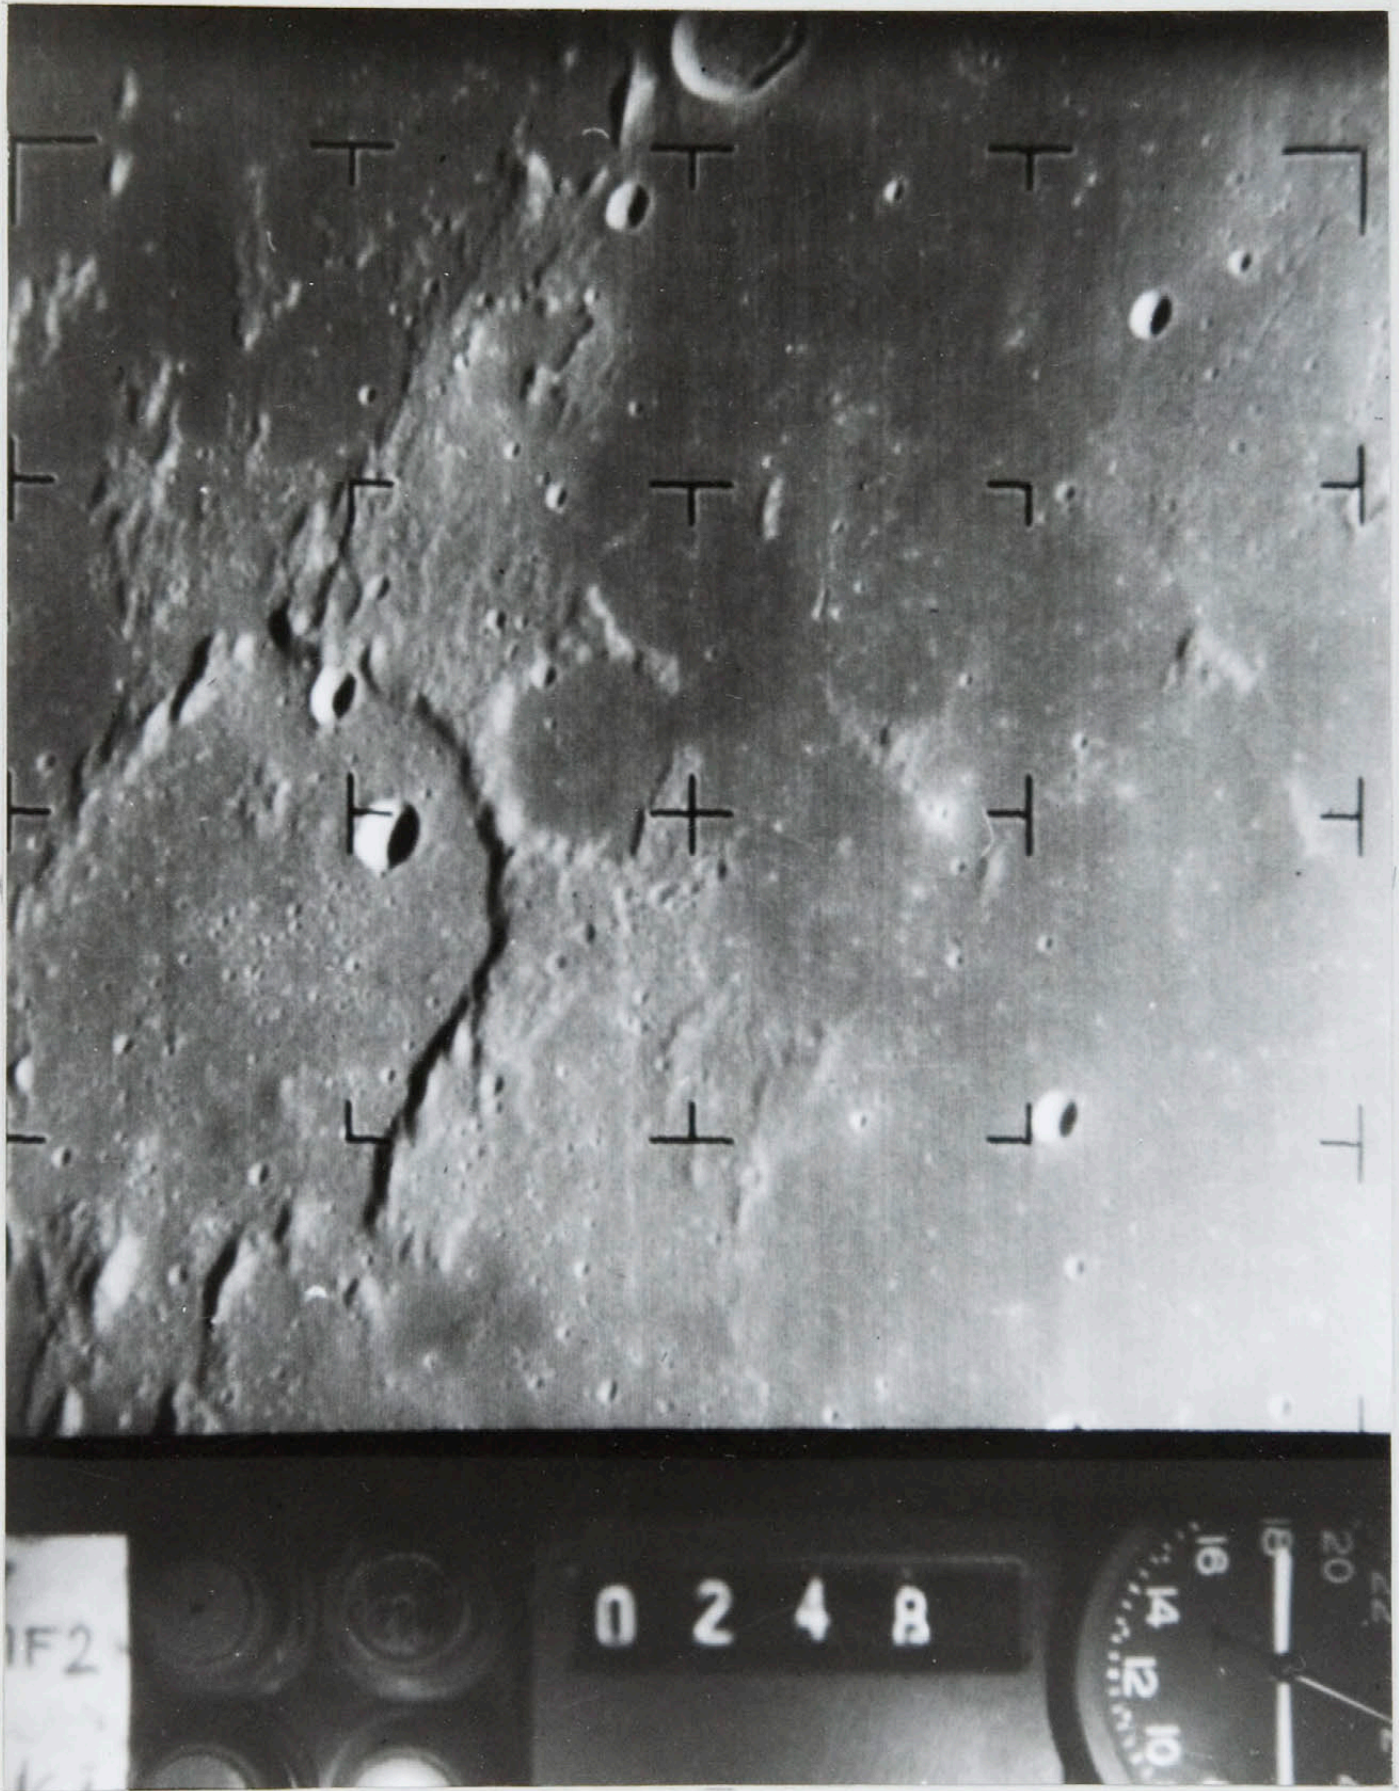
FOR RELEASE: Immediately  
PHOTO NO.: 64-Ranger B-26

Photograph taken by the Ranger VII spacecraft prior to its impact on the Moon at 6:25 a.m. EDT July 31. Viewed with the clock at the upper left hand corner. North is at the top of the photograph. The picture was taken by the F-a camera with a 25mm. f/1 lens at an altitude of about 235 miles some two-minutes-46-seconds before impact. The photo shows an area about 113 miles on a side. The eventual impact point of Ranger VII is approximately on the border between the two squares in the upper right hand corner as defined by the reseau marks. The smallest craters are about 1,000 feet in diameter and are shown with a resolution about four times Earth-based photography.

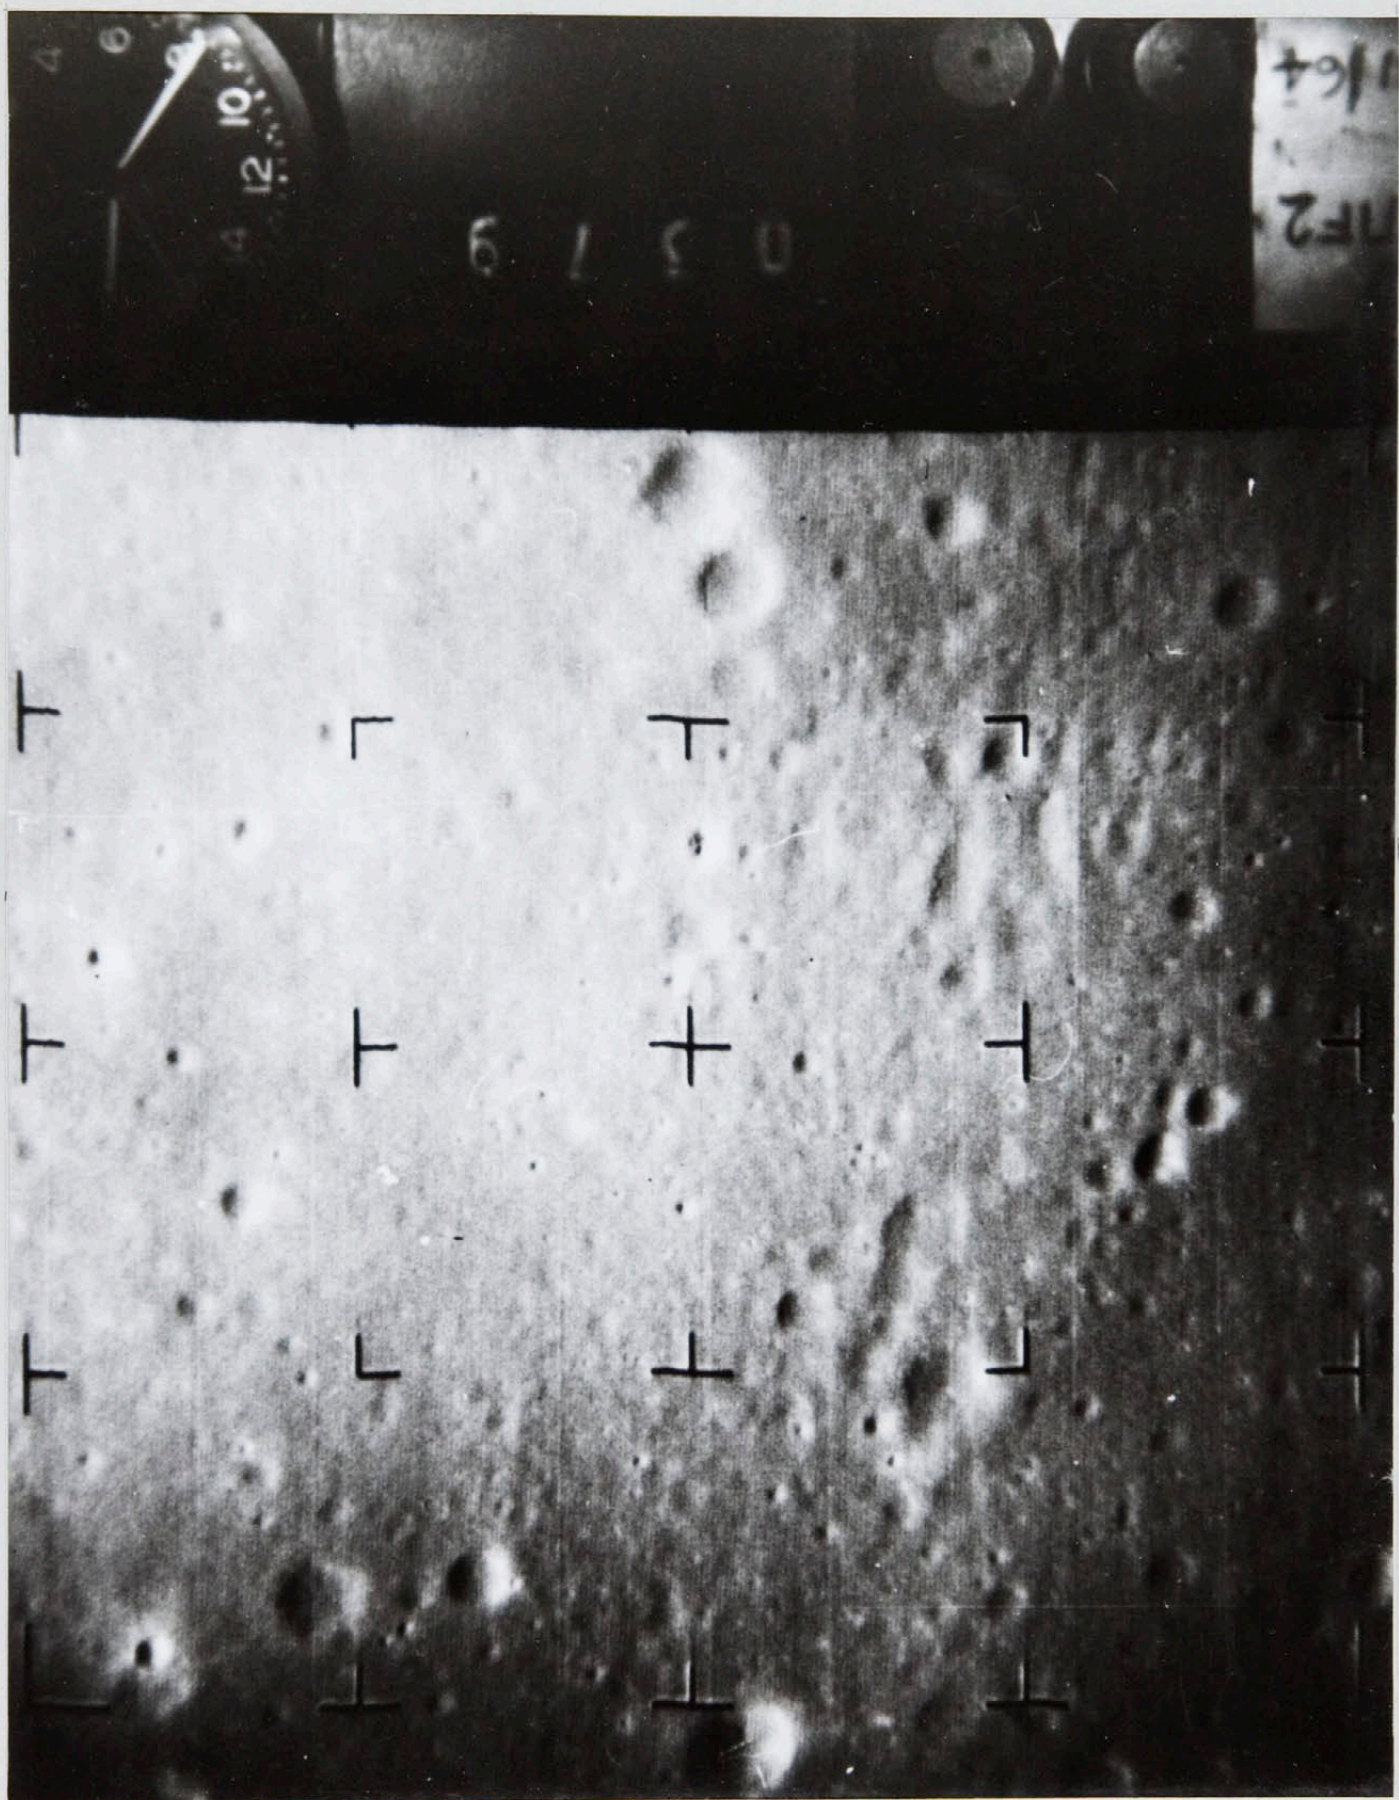
FOR RELEASE:           Immediately  
PHOTO NO.:             64-Ranger B-25

Photograph taken by the Ranger VII spacecraft before it impacted the Moon at 6:25 a.m. PDT July 31. Viewed with the largest crater in the upper right hand corner. North is at the top. It was taken by the F-b camera with a 75mm, f/2 lens at an altitude of 470 miles. It shows an area about 73 miles on a side. The smallest craters shown are about 800-feet in diameter. The large crater in the upper right-hand corner is Guericke. Numerous small secondary craters are shown on its floor as well as two large conical craters. The larger of the two is about four miles in diameter.

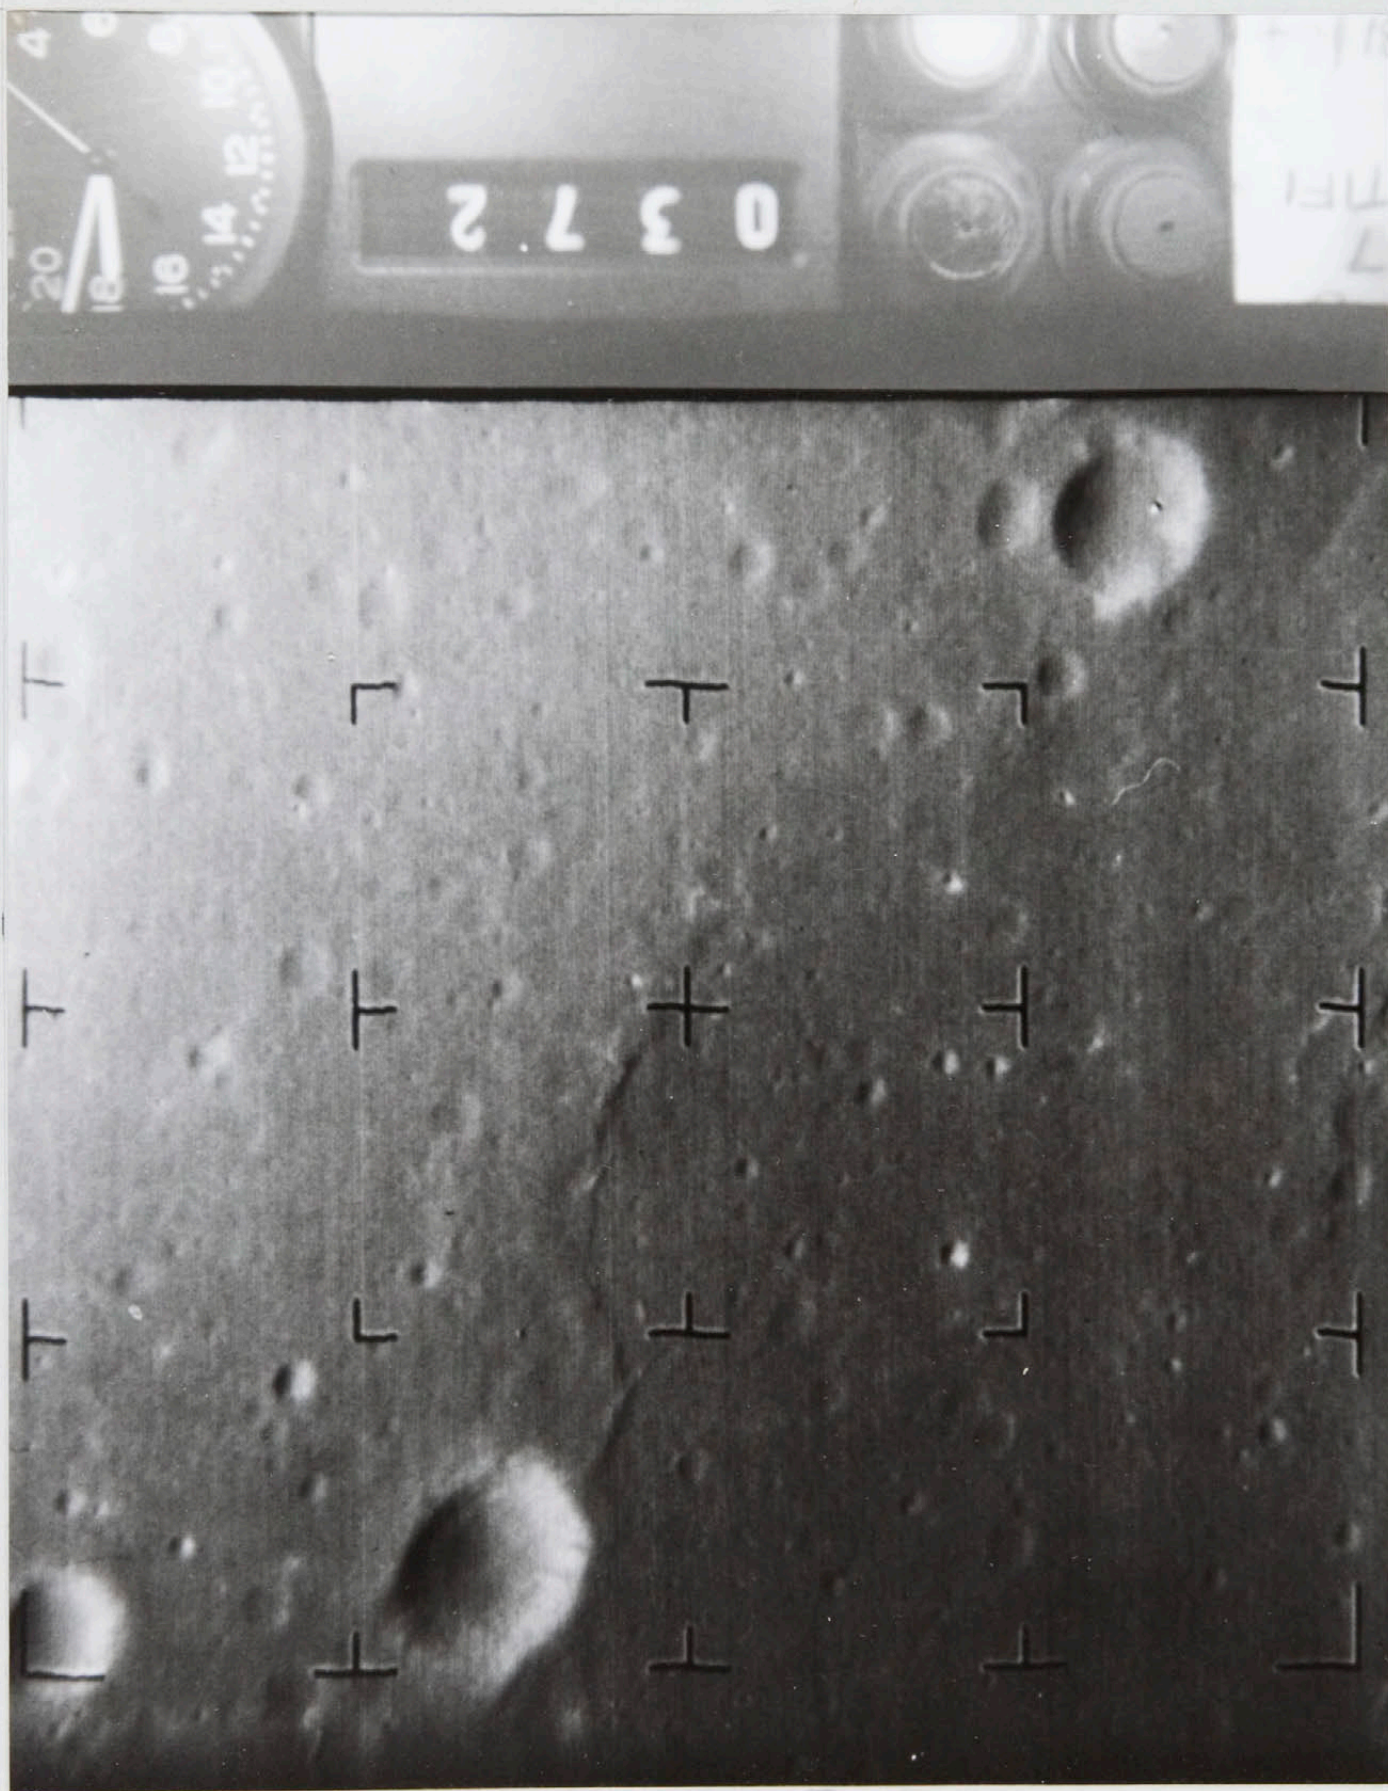
FOR RELEASE: Immediately  
PHOTO NO.: 64-Ranger B-22

Photograph taken by the Ranger VII spacecraft before it impacted on the Moon at 6:25 a.m. PDT July 31. Viewed with the three large shallow craters in the lower left hand corner, North is at the top of the picture. It was taken by the P-a camera with a 25mm, f/1 lens from an altitude of 480 miles. It duplicates closely resolution obtained in Earth-based photography. The large open dark crater in lower margin is Lubiniesky.
